## Home Inspection Report

PROPERTY INSPECTED:  
**21 Albertus Avenue**  
**Toronto, ON M4R 1J5**

**Date of Inspection: 06/19/2026**

Inspection No. 141168-1977

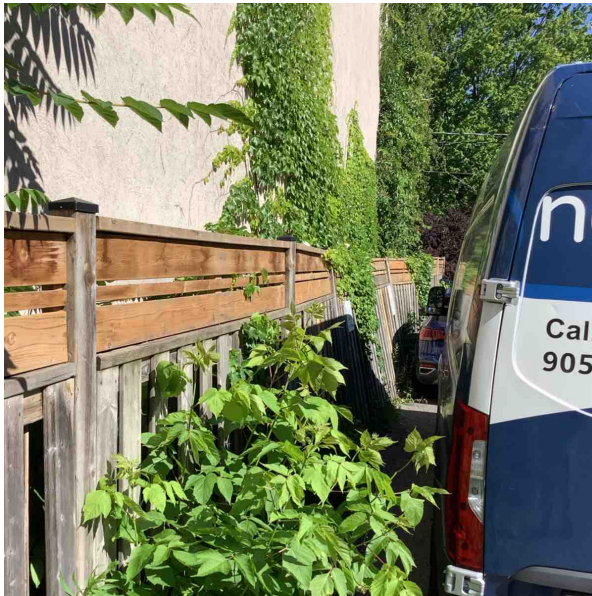
3.1.2 The wood fence on the east side is leaning. Recommend a consult the neighbouring property owner to coordinate repair.

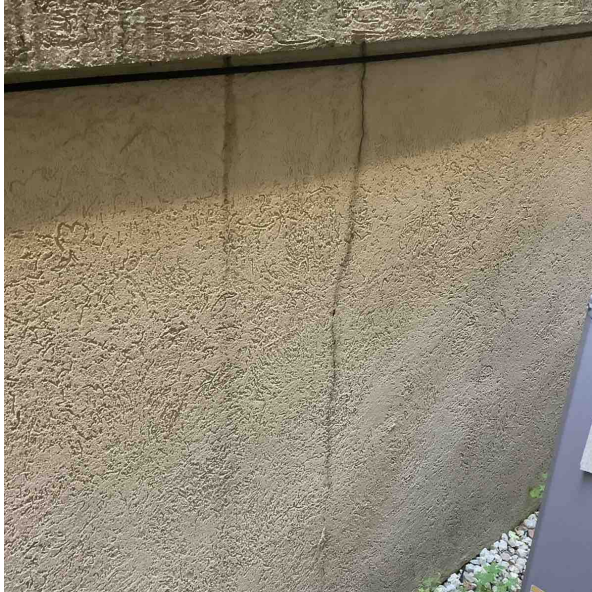
3.2.2 A crack in the coating is visible along the west side. As this is strictly in the coating, no immediate improvement is required. Ideally, it is recommended to have any crack sealed to help prevent further expansion by a qualified contractor.

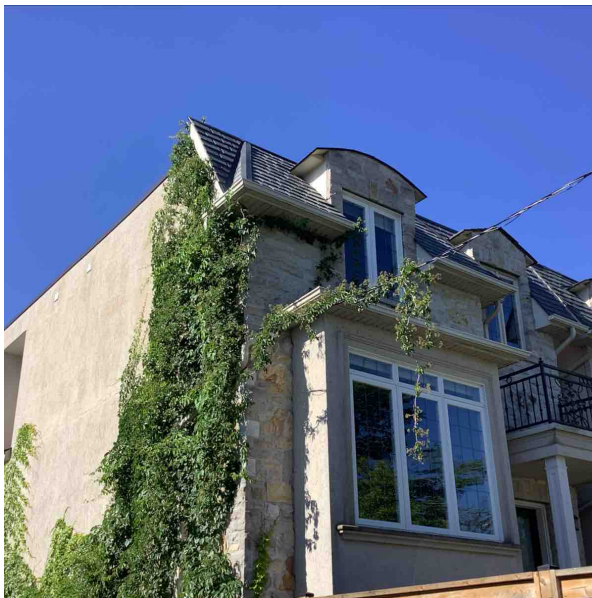
3.3.2 Vines and vegetation may damage the wall surface. Maintain, trim or remove as necessary.

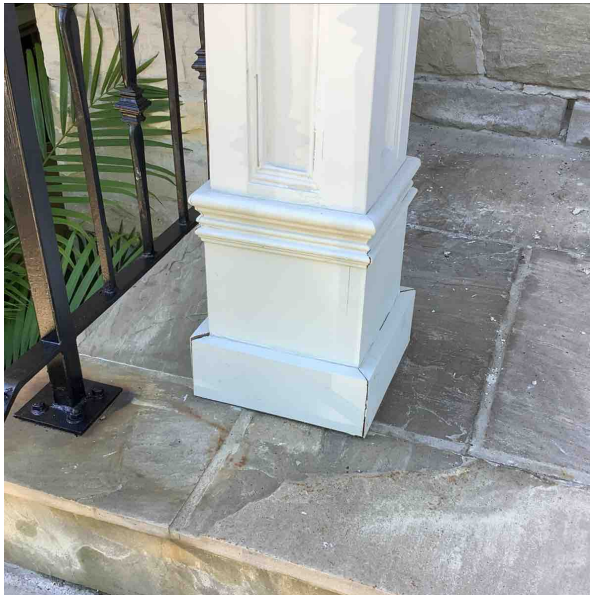
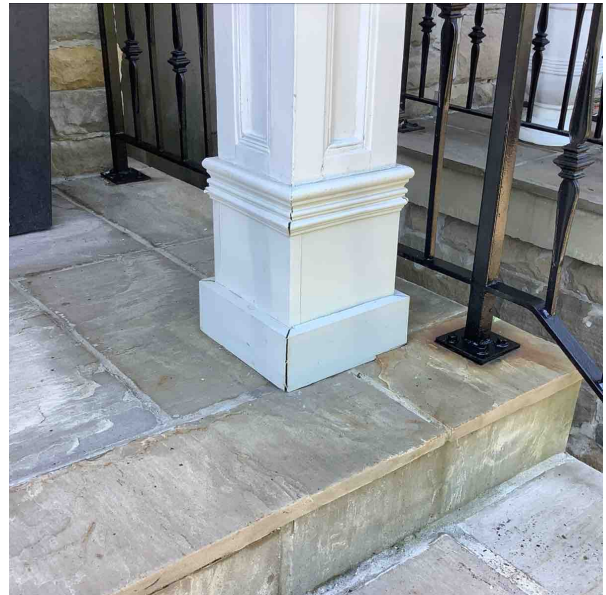
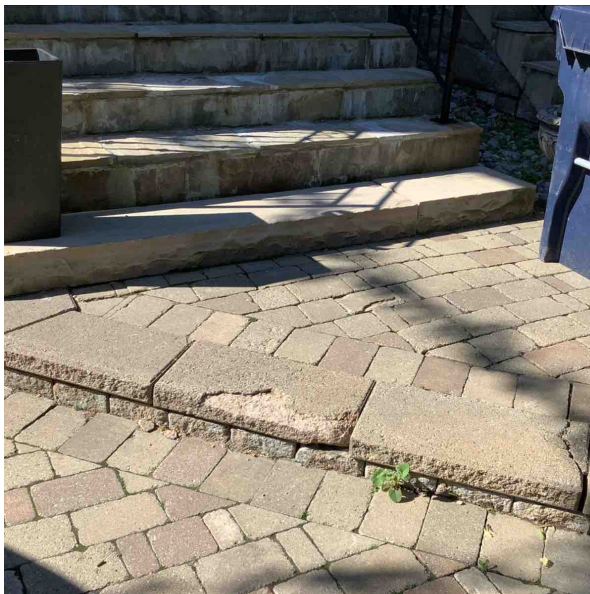
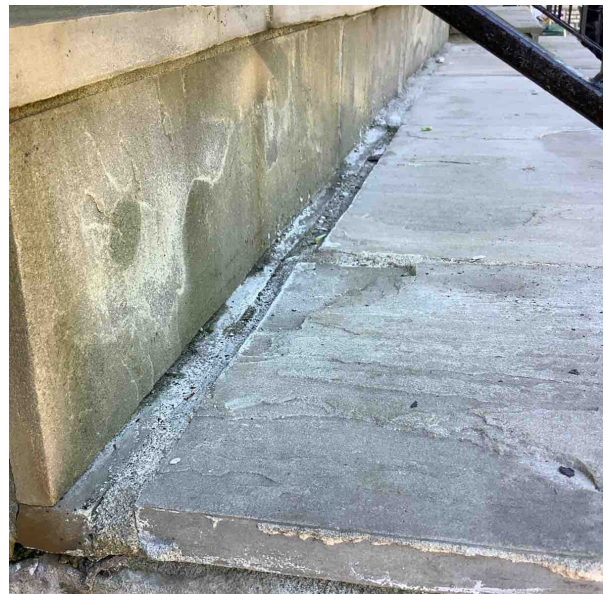
3.7.2 The front porch is functional, showing some gaps in the framing of the wood posts and some deterioration in some of the pavers & mortar. While no immediate improvement is required, recommend a consider a handyman or qualified contractor to repair.

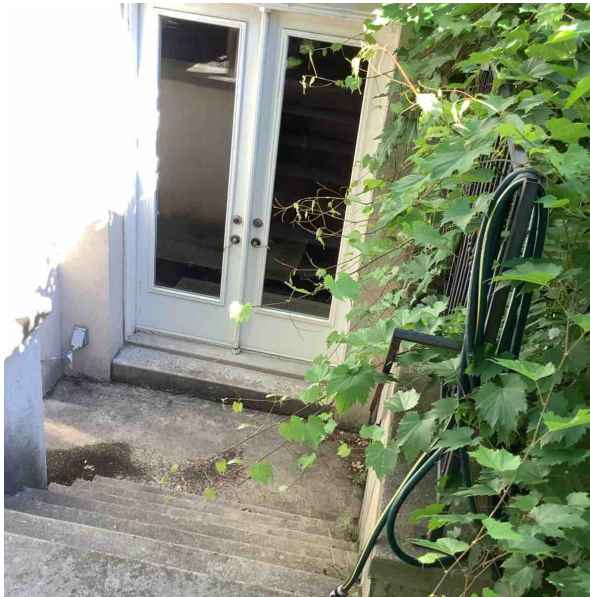
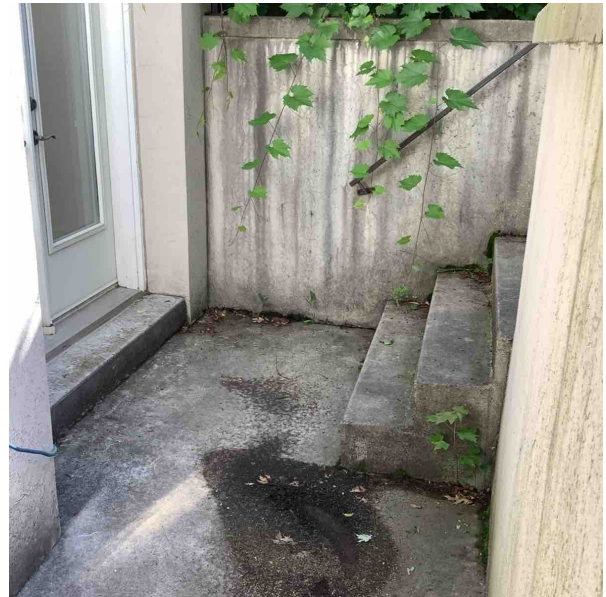
3.9.2 The basement walkout has the required railing, but is missing a drain. Recommend consider installing a drain.

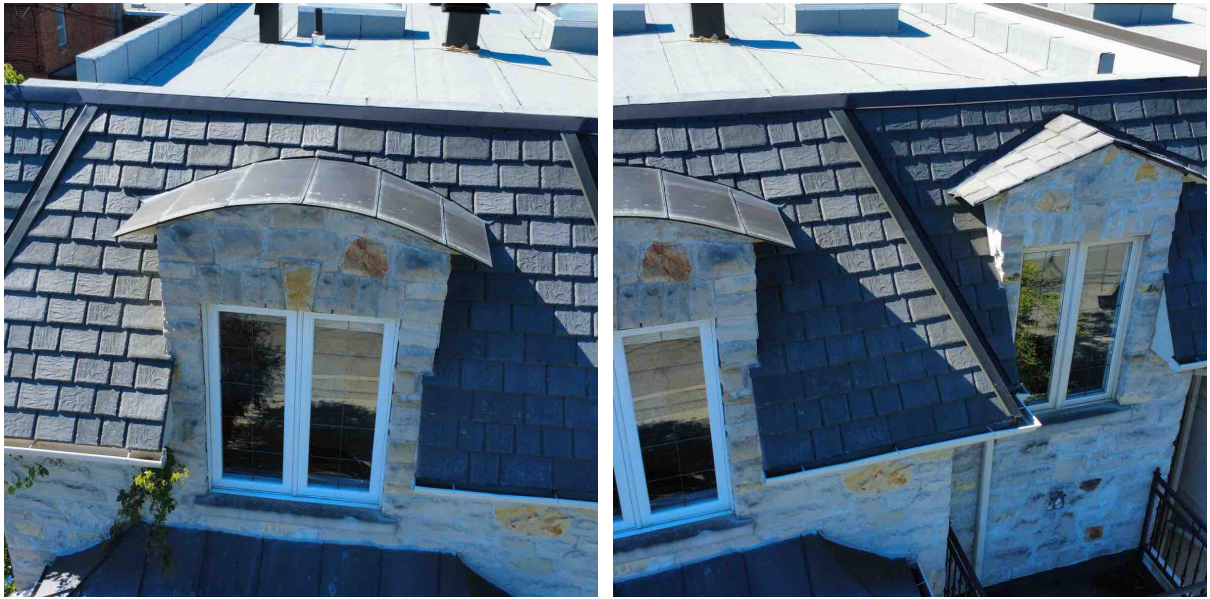
4.2.4 Composite tile shingles are premium quality, estimated to be 18 years old, middle of life cycle, and in satisfactory condition.

Typical life expectancy is 40 to 70 years.

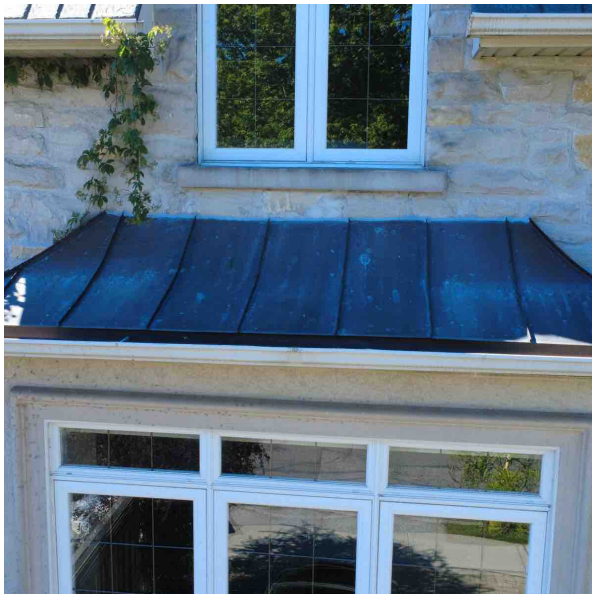
4.2.5 Metal flashing/roof is in satisfactory condition. Estimated to be 18 years old.

Typical life expectancy is 40 to 70 years.

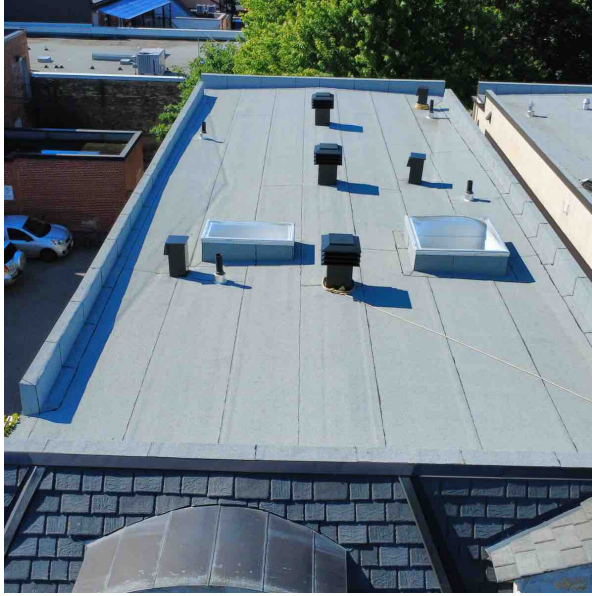
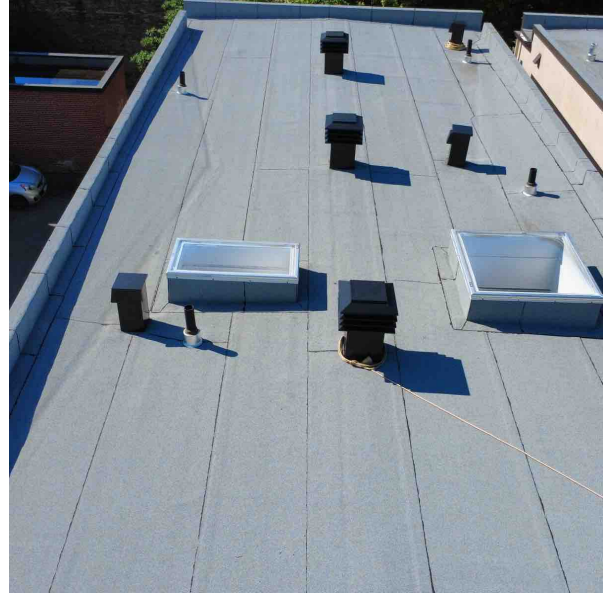
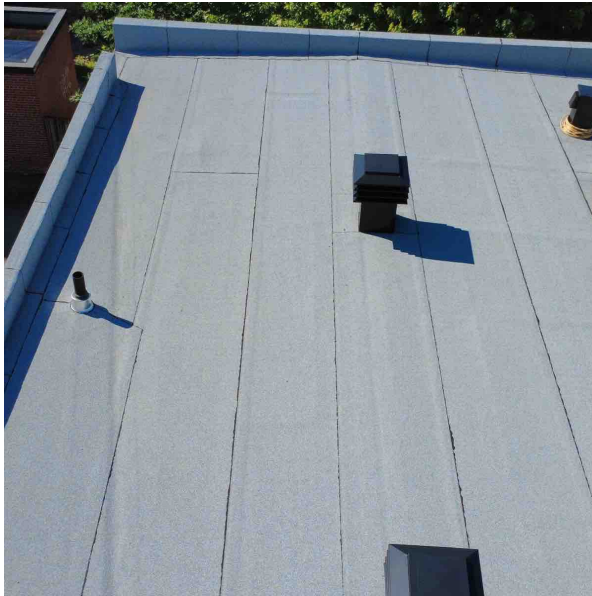
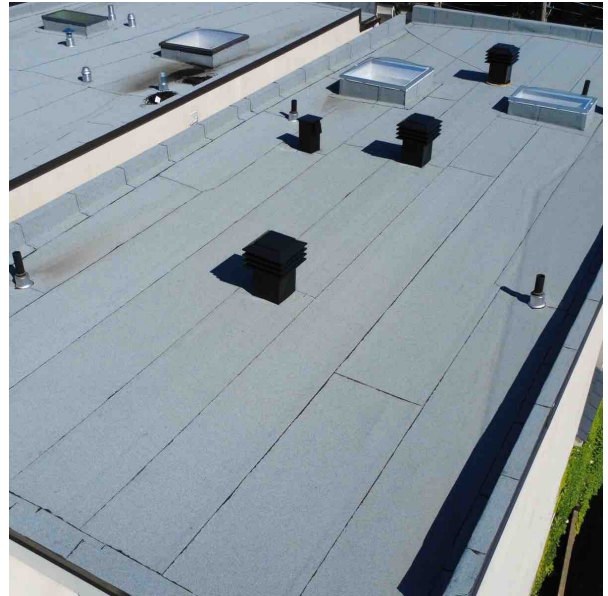
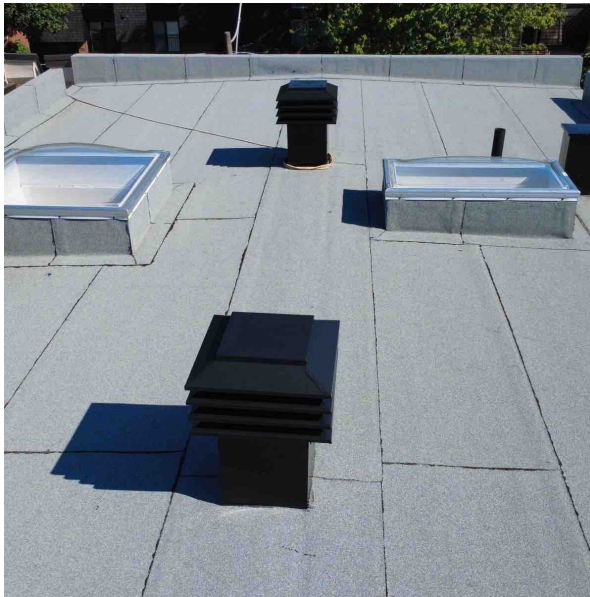
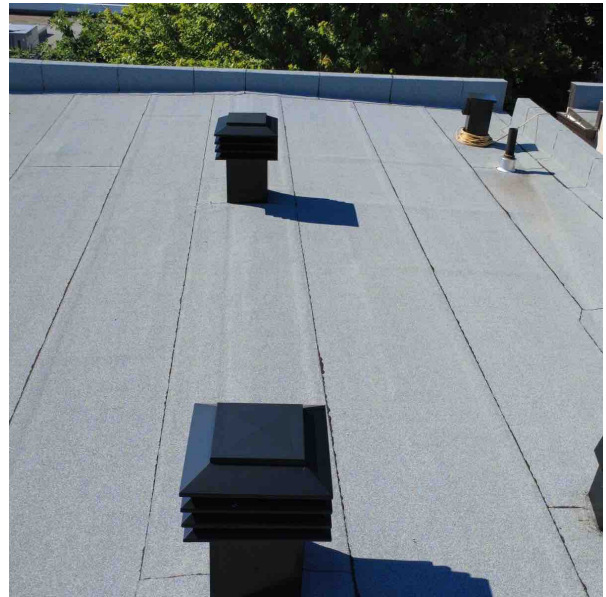
4.3.2 The flat roof membrane is estimated to be 7 years or less, beginning of life cycle and in satisfactory condition.

Typical life expectancy is 15 - 20 years.

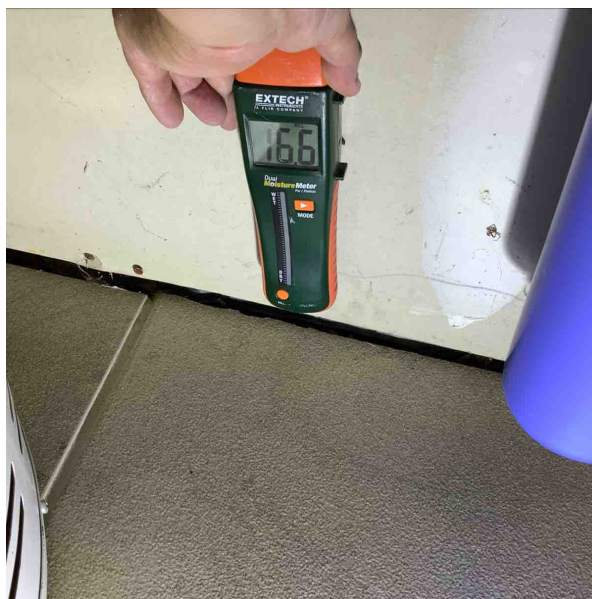
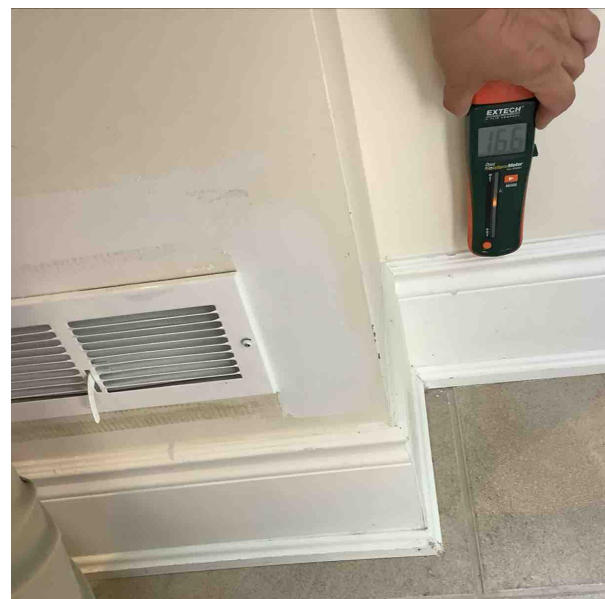
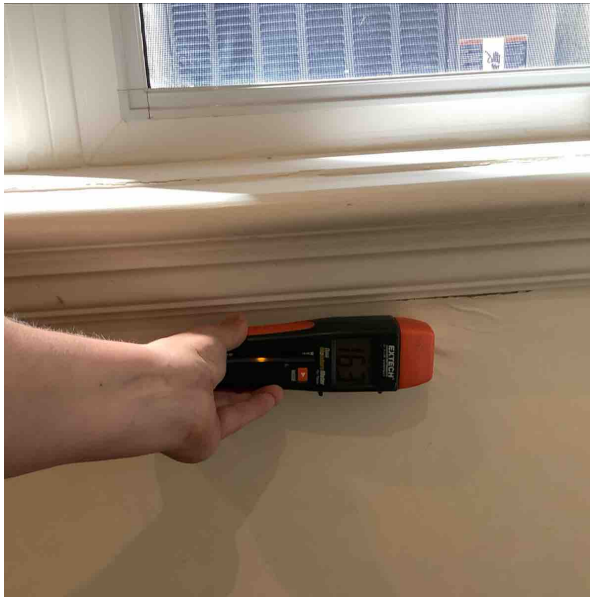
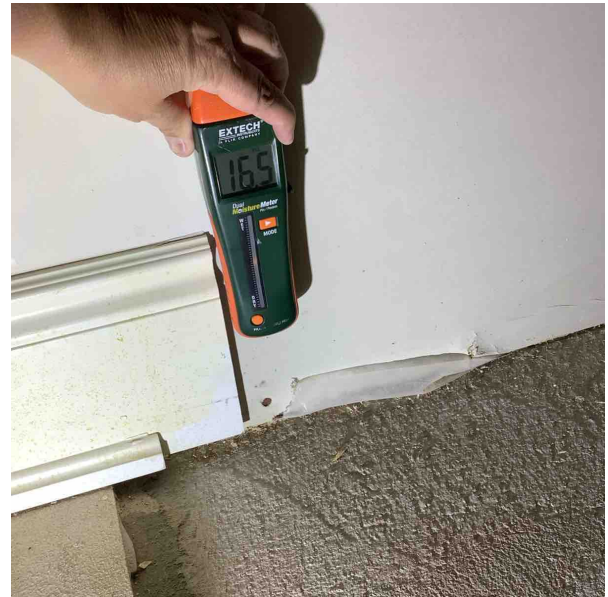
7.2.3 **Concrete foundation was concealed behind drywall, had normal moisture readings, no signs of seepage, nor efflorescence or water stains, and is in satisfactory condition.**

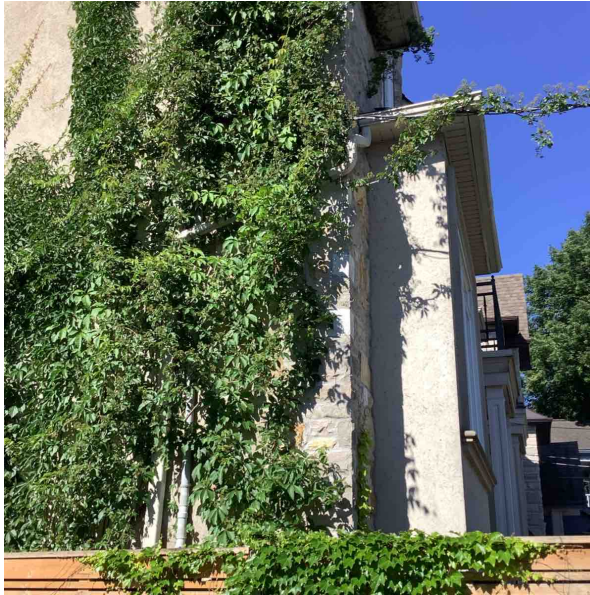
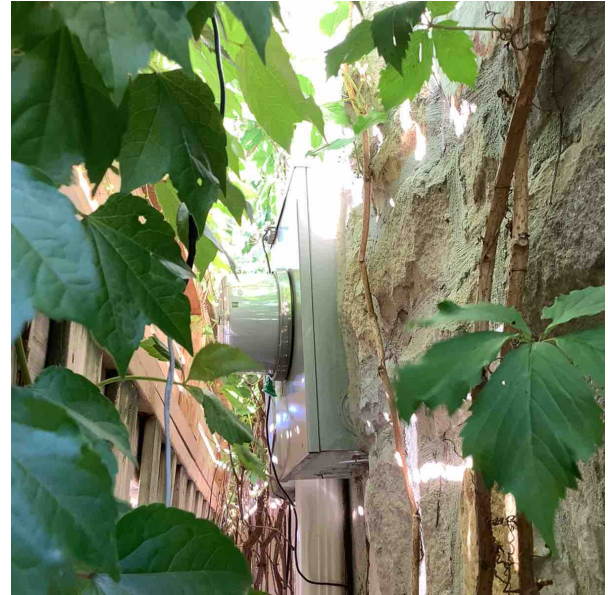
8.2.1 Overhead service entrance cables to a meter located outside at SE corner. The majority of the service entrance and metre are concealed by the overgrown vegetation. Recommend to consider trimming back.

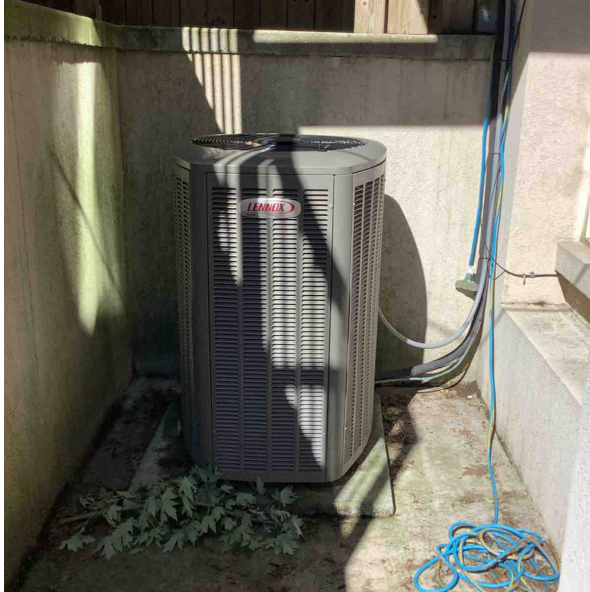
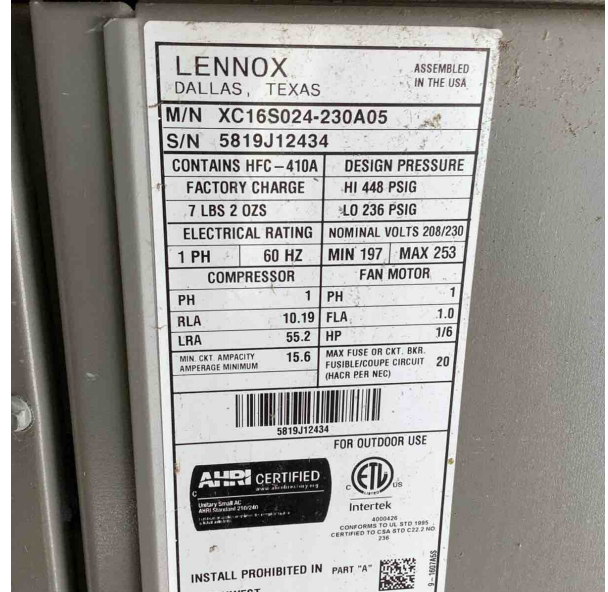
9.3.3 Lennox AC unit has 2.0 ton cooling, 7 years old, middle of life cycle, and is in satisfactory condition.

Typical life expectancy is around 15 years.

9.3.4 While it was functional, recommend a HVAC technician service the unit annually to maintain performance and prolong service life.

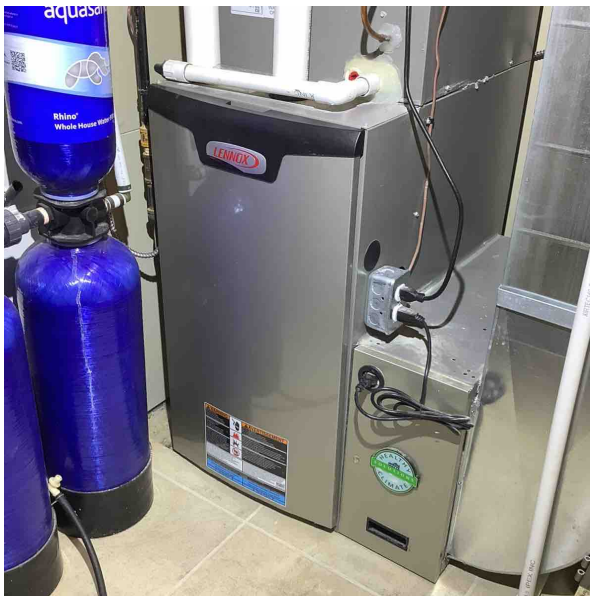
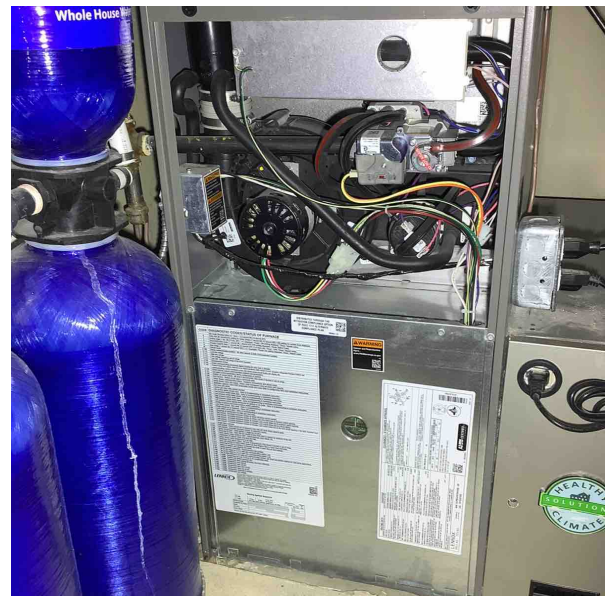
9.4.2 Lennox Hi Eff furnace has 66,000 BTU / Hr Input, is 7 years old, middle of life cycle and was functioning at time of inspection.

Typical life expectancy is around 20 years.

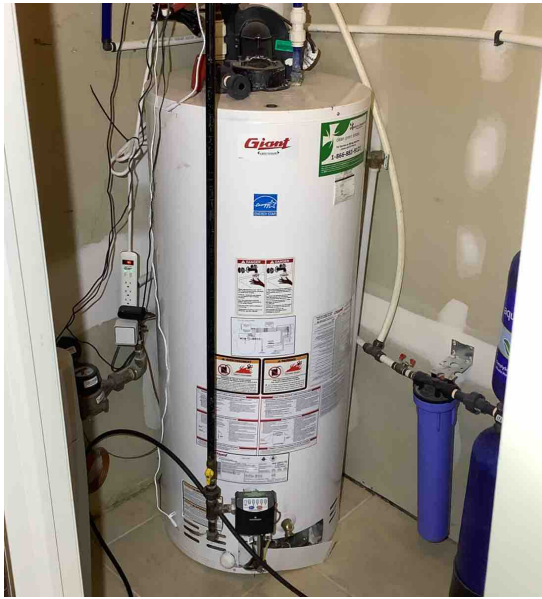
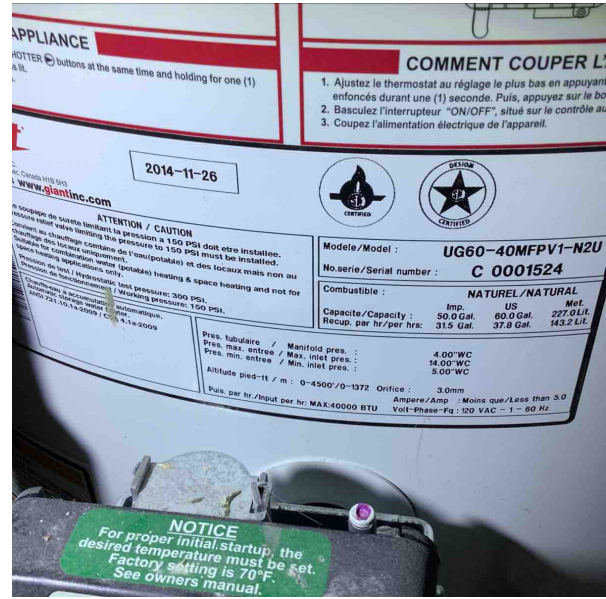
Typical life expectancy is 10 - 12 years.

While additional years may remain, recommend to budget for replacement.

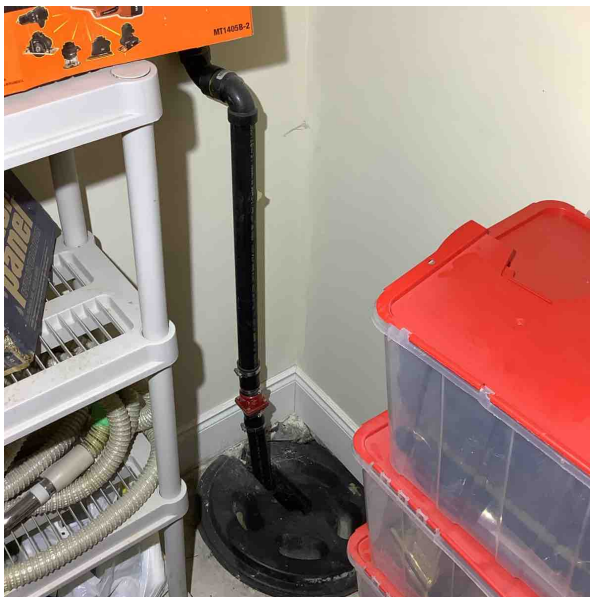
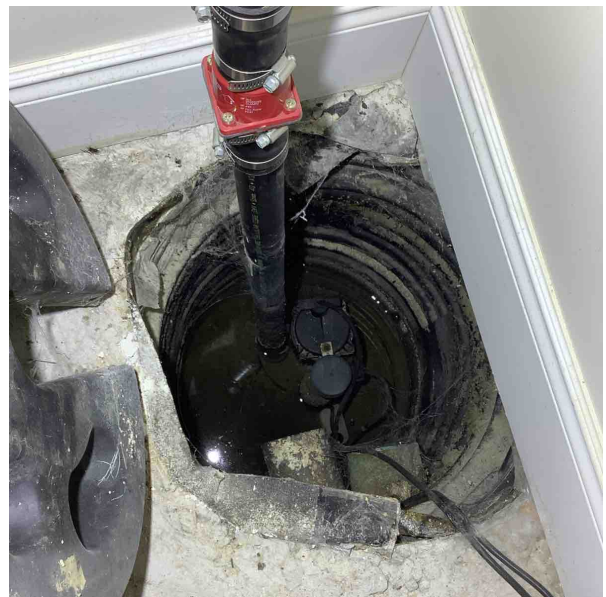
10.13.2 **The sump pump is present in the basement at the NW corner and is connected to discharge to the outside. Unit was not tested during the inspection, due to the low water levels.**

10.13.3 A battery backup / high water alarm for the sump pump is not present. Recommend consider installing a battery backup / high water alarm to ensure proper function in the event of a mechanical failure or power outage.

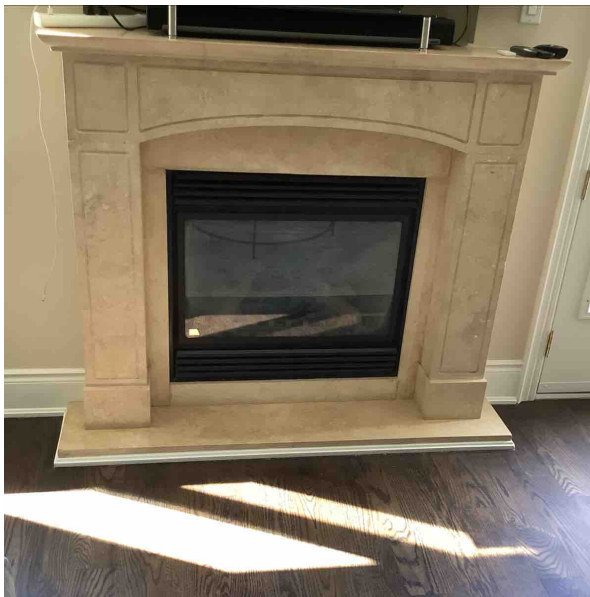
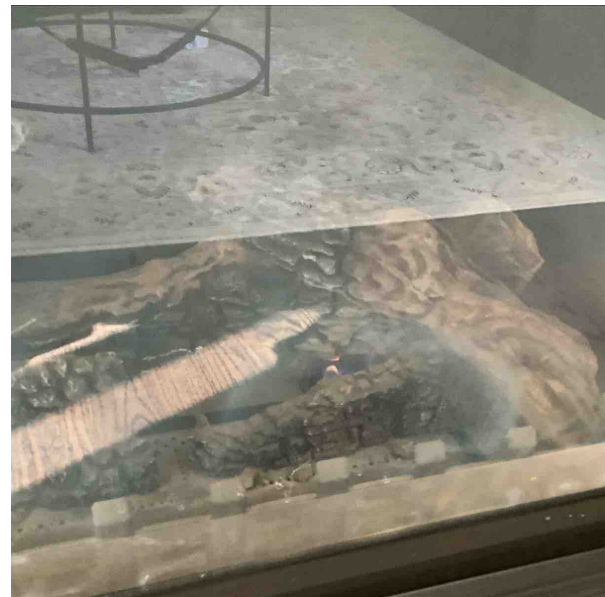
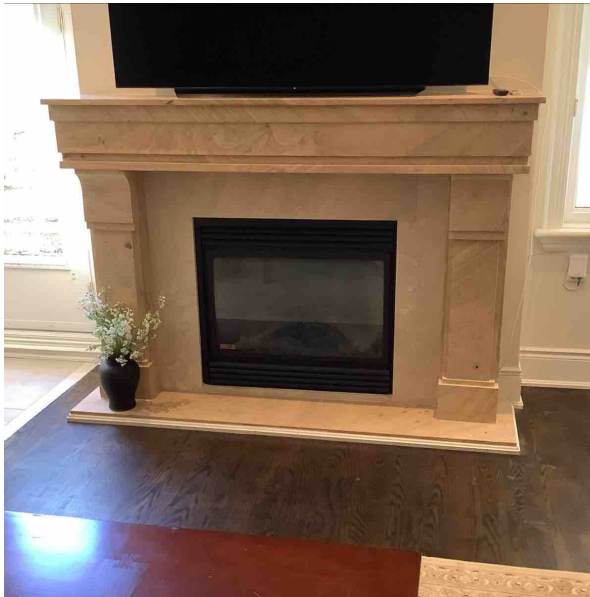
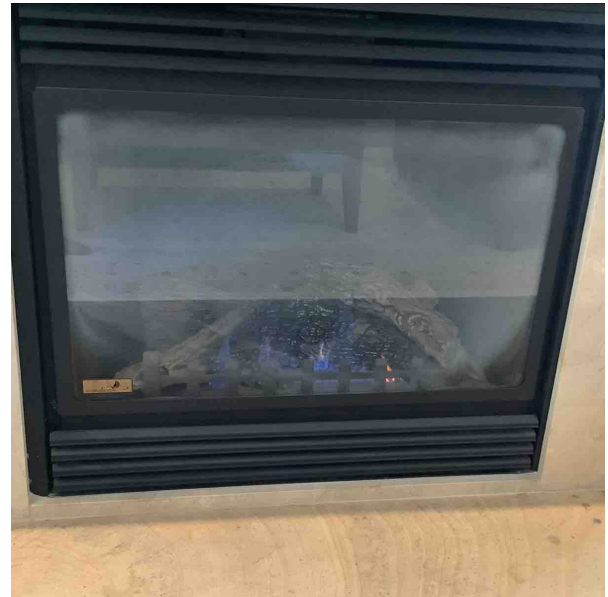
12.1.2 Gas fireplaces were present, was operational when tested, however the safety of the unit was not determined. If the smell of gas or irregular function is noticed, recommend a qualified gas heating technician inspect the unit & connections to determine functionality and compliance with modern safety standards.
